Inspection Report

Property Address:

Strickland Construction

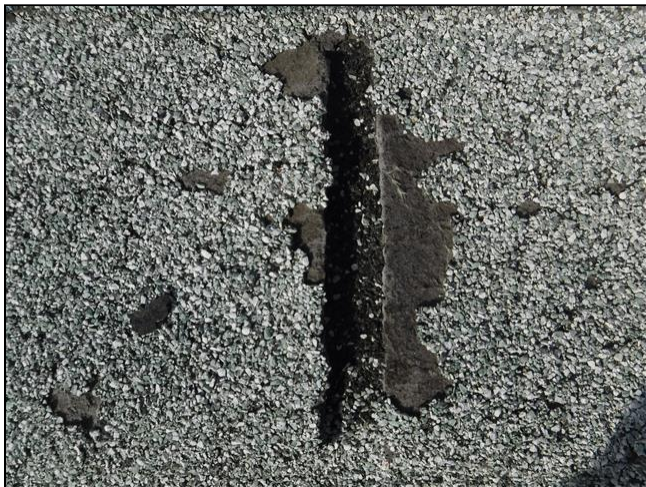
1.0 Item 1(Picture)

1.0 (1) Shingles are cupping, blistering and falling apart due to insufficient underlayment, ventilation and attic insulation I recommend getting the roof replaced by a licensed roofing contractor as soon as possible to avoid water penetration into home.

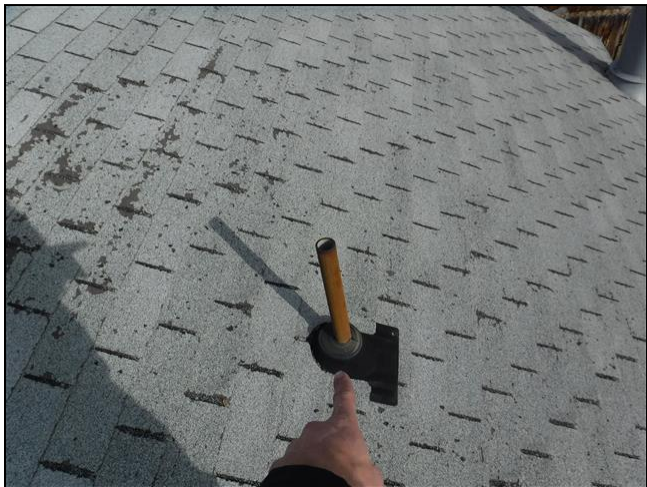
1.1 Item 1(Picture)

1.1 The vent flashings are cracked and failing. These should be replaced as soon as possible to prevent water penetration into home. A licensed roofing contractor should perform the repairs.

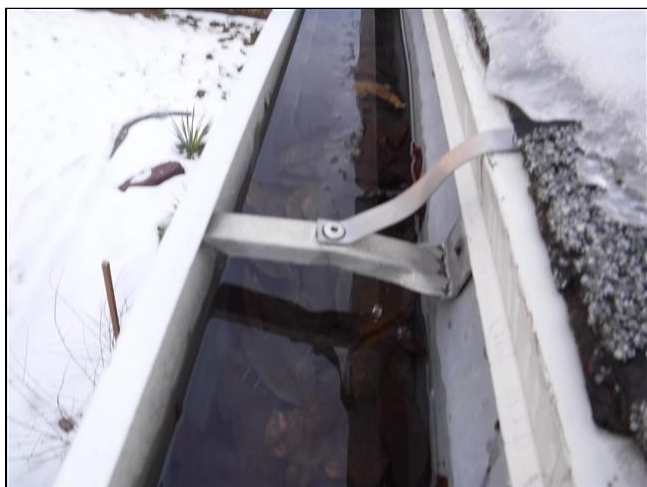
1.3 Item 1(Picture)

1.3 (1) Gutters on home need to be cleaned out in order to drain properly.

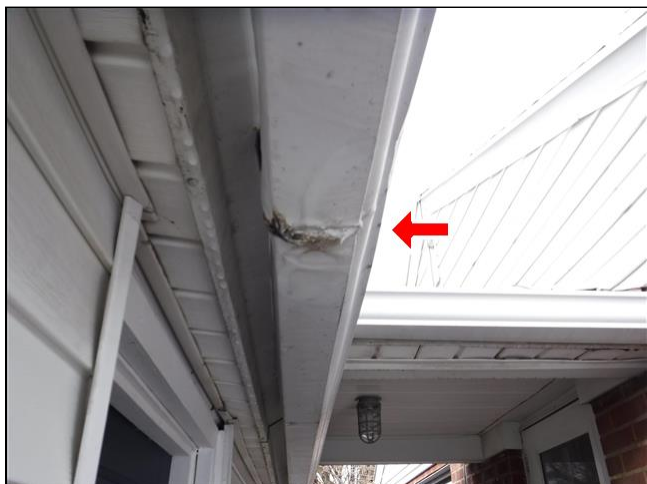
1.3 Item 5(Picture)

1.3 (3) Gutter between home and garage is broken and leaking. A licensed gutter contractor should repair or replace as needed.

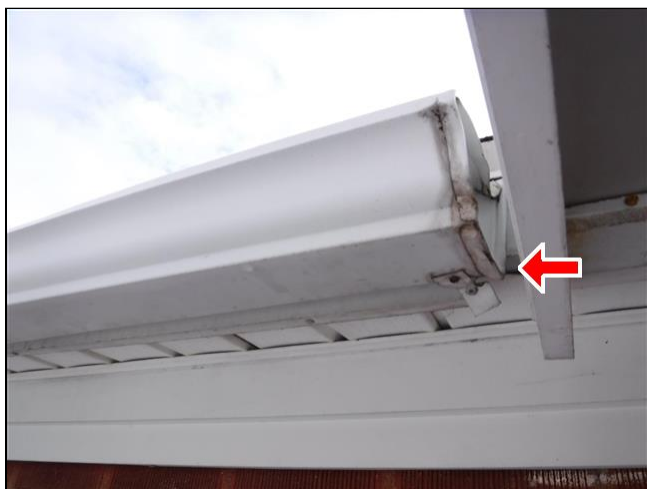
1.3 Item 7(Picture)

1.3 (4) End cap on front gutter of home is leaking. A qualified handyman should clean and re-seal as needed.

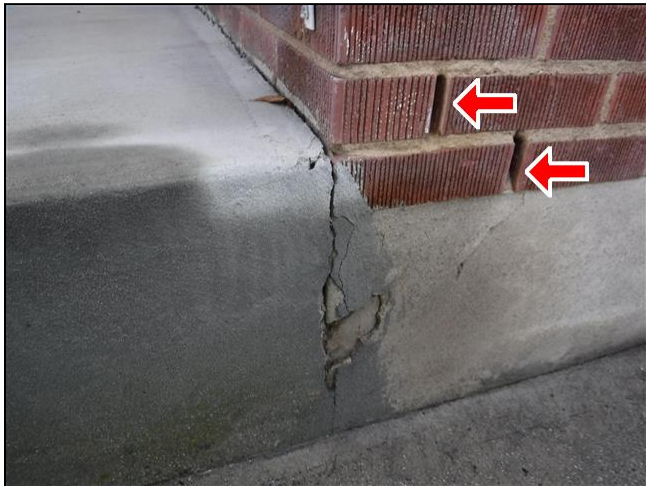
2.0 Item 1(Picture)

2.0 (1) Brick is missing mortar in various locations around exterior of home. A licensed brick mason should repair as needed.

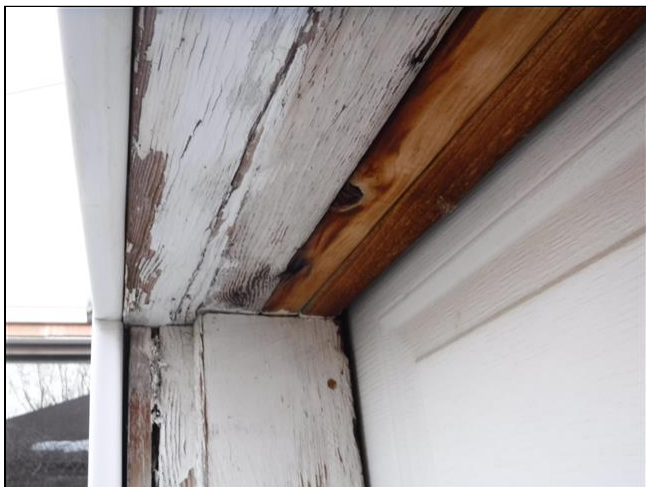
2.0 Item 5(Picture)

2.0 (2) Wood on garage needs scrapping and new paint. A qualified handyman should perform repairs.

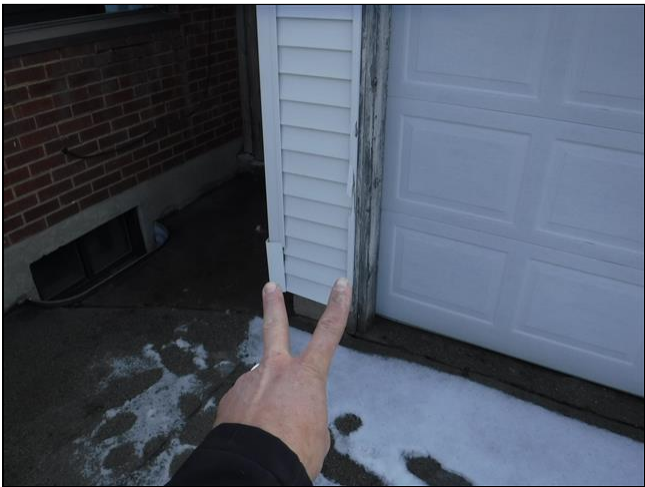
2.0 Item 8(Picture)

2.0 (3) Garage has damage to siding/trim. A licensed siding contractor should repair or replace as needed.

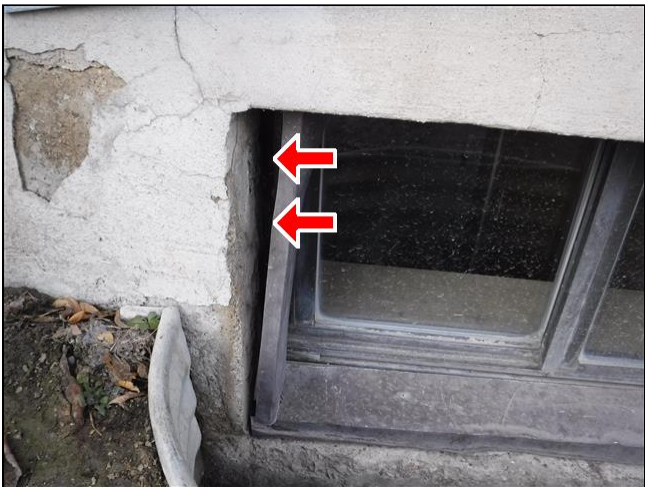
2.2 Item 1(Picture)

2.2 Laundry window has casing that is pulling away. A qualified handyman should reattach and re-seal

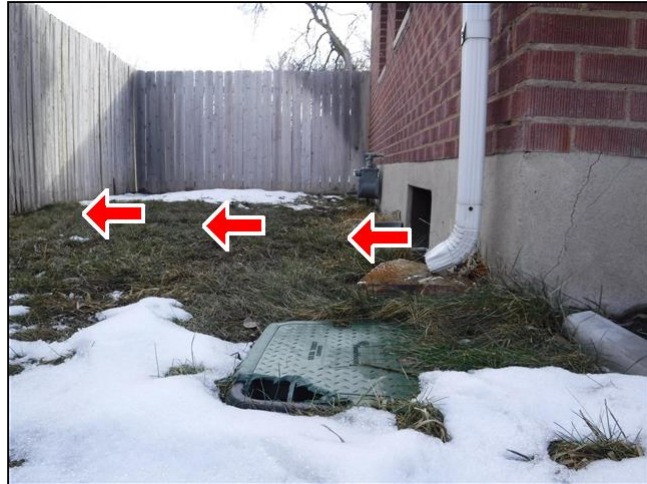
2.4 Item 2(Picture)

2.4 (1) There is a negative slope at the left side (facing front) and rear of home. This can cause or contribute to water intrusion or deterioration. I recommend correcting landscape to drain water away from home.

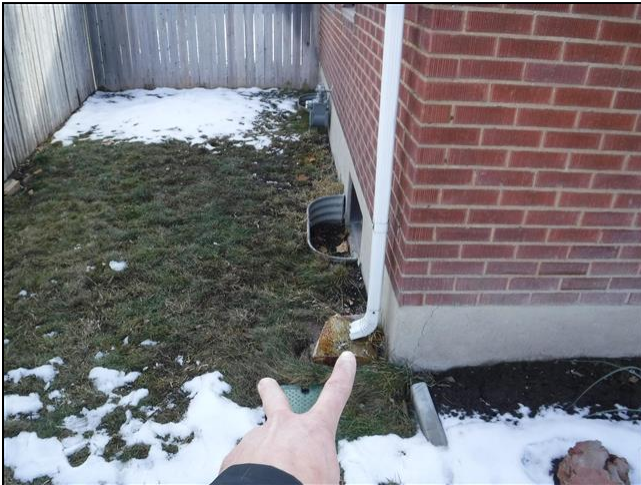
2.4 Item 3(Picture)

2.4 (2) Downspouts should be extended to direct water away from foundation of home. A qualified handyman should perform repairs.

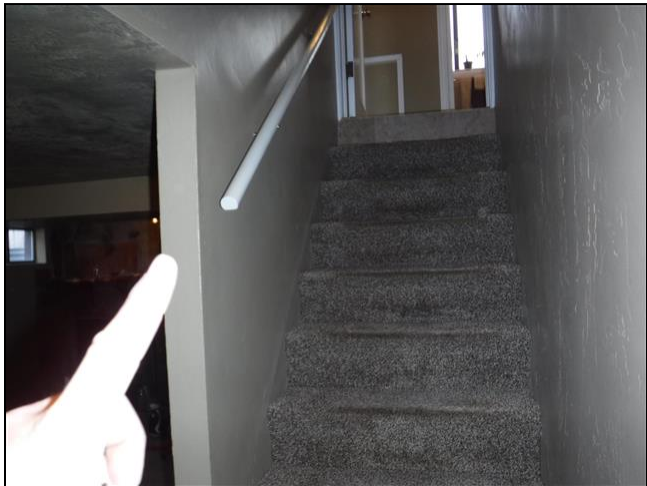
4.3 Item 1(Picture)

4.3 Railing ends 3 steps before bottom of stairs. A railing should be installed on other wall so that it can service the full staircase.

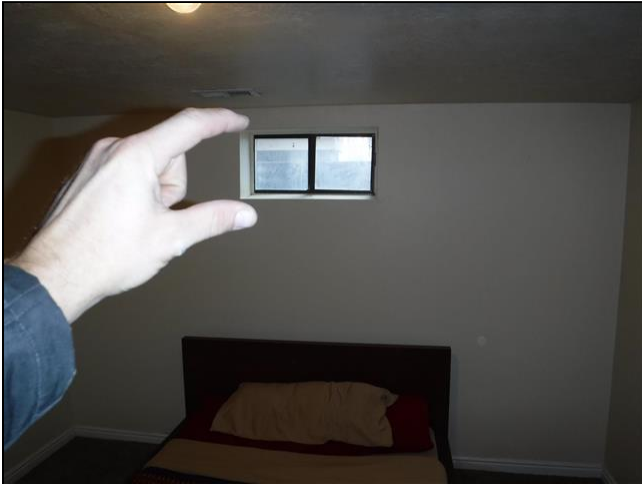
4.6 Item 1(Picture)

4.6 (1) Basement bedroom window does not meet egress standards. This room should not be used as a bedroom without proper fire escape through window opening.

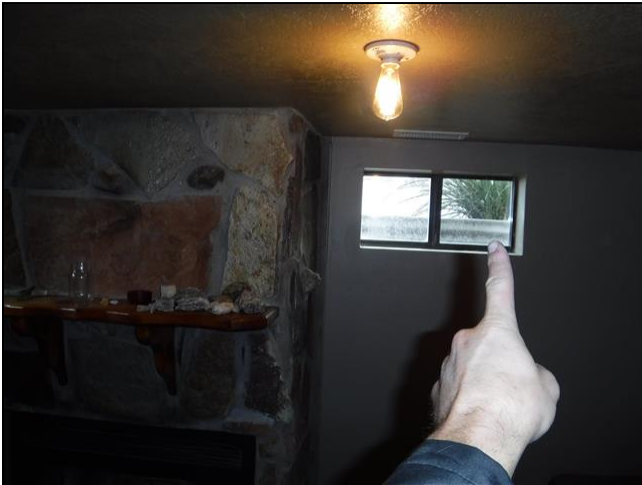
4.6 Item 2(Picture)

4.6 (2) Window pane is cracked next to basement fireplace. A licensed window contractor should replace broken window pane.

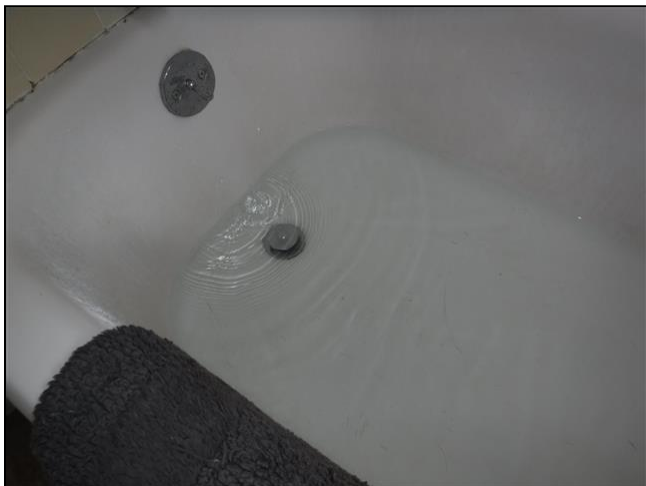
6.0 Item 3(Picture)

6.0 (2) Upstairs sink and bath tub have slow drains. A plumber should further evaluate and clear drains or fix vents as needed.

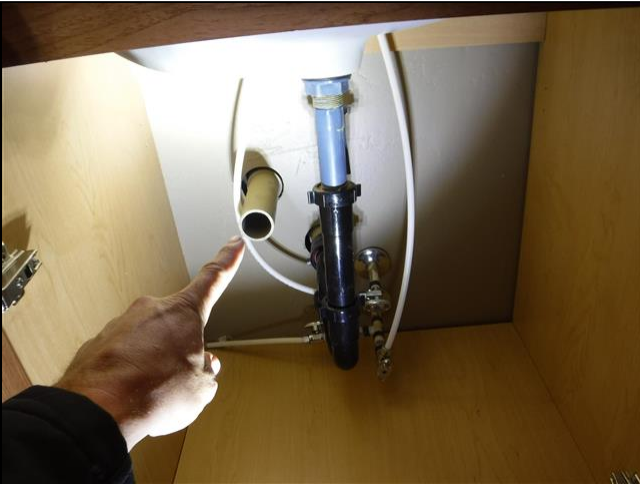
6.0 Item 5(Picture)

6.0 (3) Vent caps need to be installed in kitchen and basement bathroom. Work should be done by a qualified handyman.

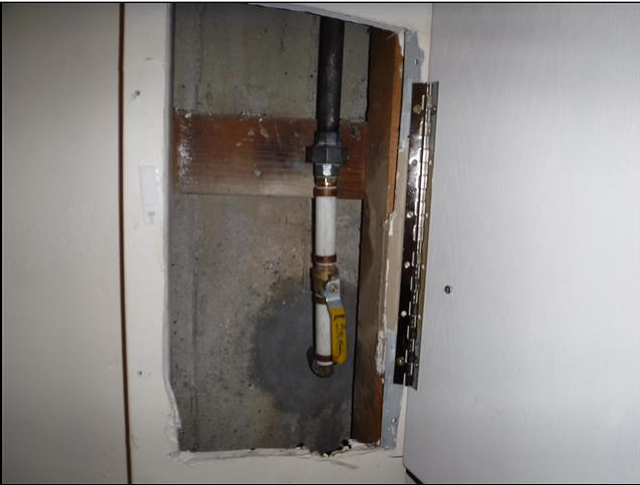
6.3 Item 1(Picture)

6.3 (1) Main water shut off is in basement bedroom.

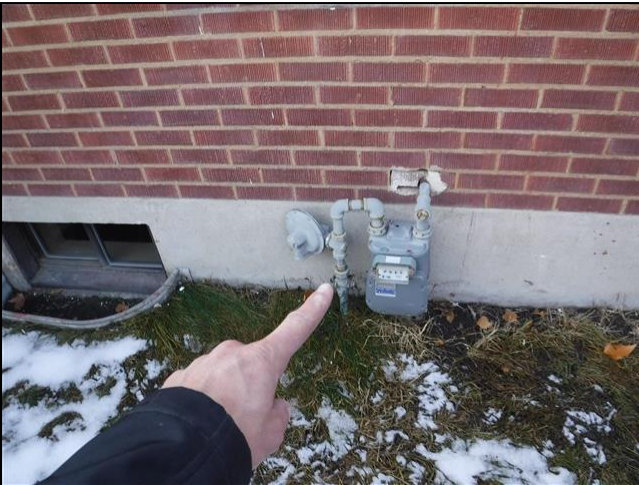
6.5 Item 1(Picture)

6.5 Main fuel shut off is on gas meter on left side (facing home).

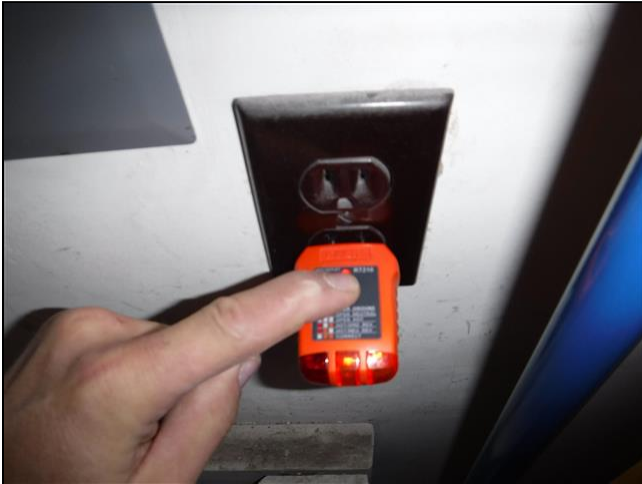
7.5 Item 1(Picture)

7.5 (1) Garage outlets are not protected by GFCI outlets. A licensed electrician should install GFCI protection as needed.

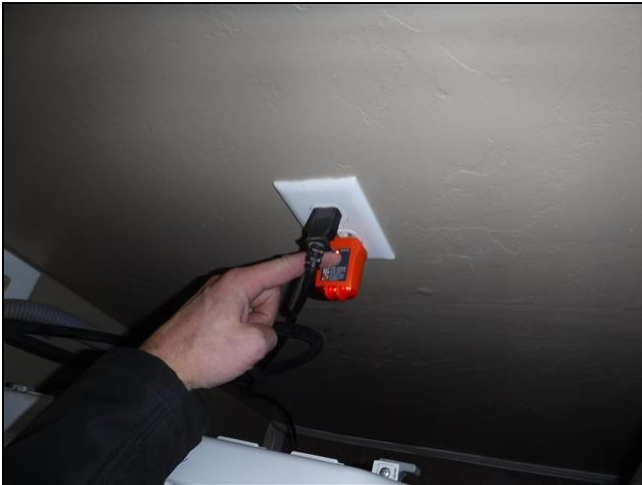
7.5 Item 2(Picture)

7.5 (2) Outlet behind washing machine is not properly GFCI protected. A licensed electrician should install GFCI outlet.

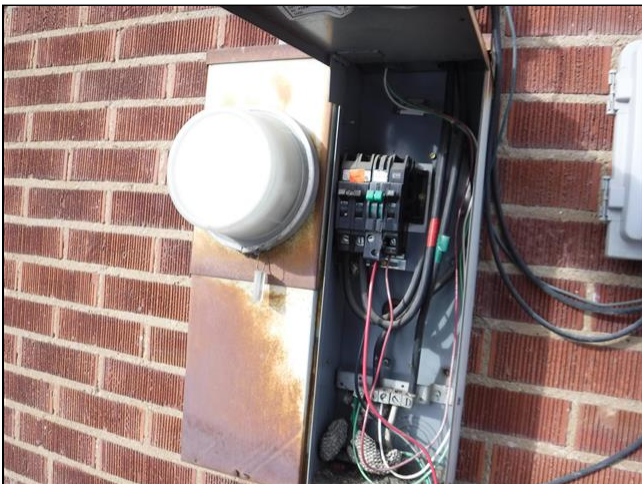
7.6 Item 1(Picture)

7.6 Main panel is out back and sub panels are in garage and stairwell.

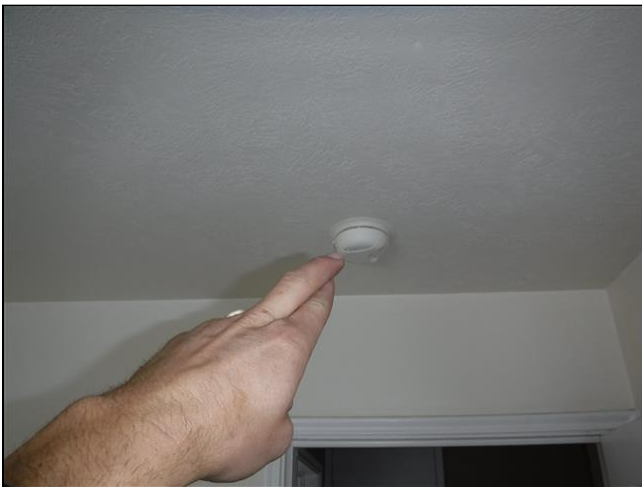
7.7 Item 1(Picture)

7.7 The smoke detector should be tested at common hallway to bedrooms upon moving in to home. Smoke detector in upstairs bedroom is not functioning properly. The battery or the whole smoke detector should be replaced as needed.

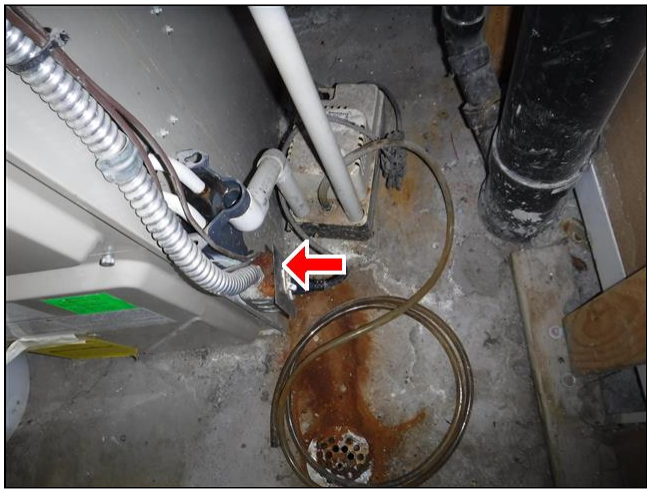
8.0 Item 2(Picture)

8.0 (2) There is water damage to the power control for the heater. A licensed HVAC professional should repair or replace damaged parts as necessary.

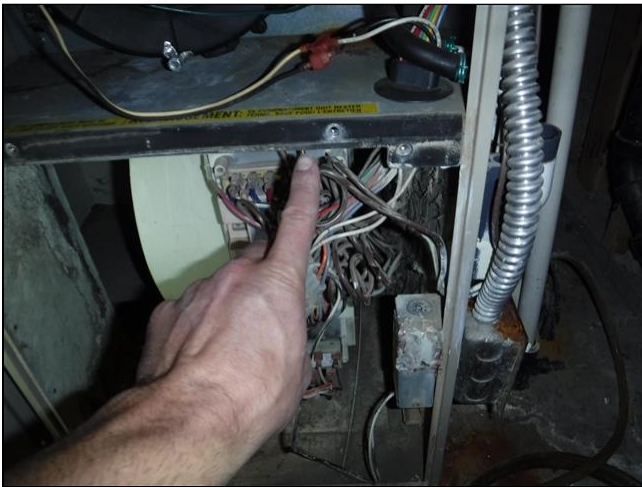
8.2 Item 1(Picture)

8.2 Automatic safety control is missing. A licensed HVAC specialist should install proper safety control.

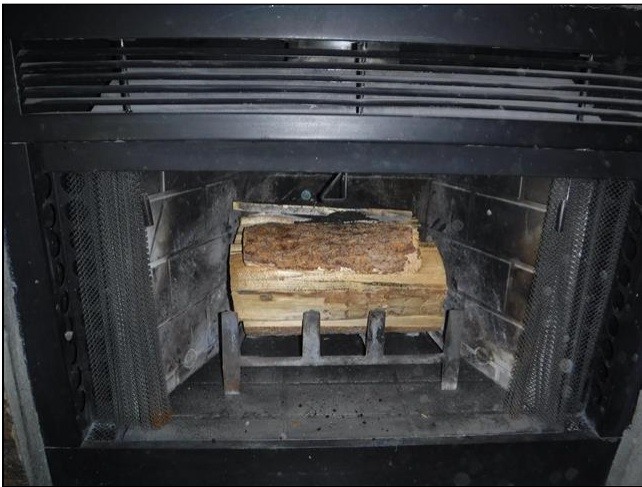
8.6 Item 1(Picture)

8.6 You should not burn wood in a gas fireplace. This can be a fire hazard and could fill your home with smoke.

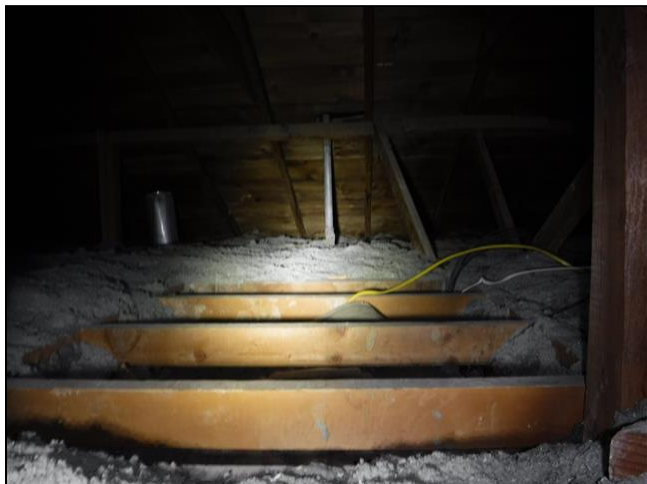
9.0 Item 1(Picture)

9.0 There is insufficient insulation in attic and no insulation on access panel. Proper insulation should be installed to prevent heat loss and high heating costs.

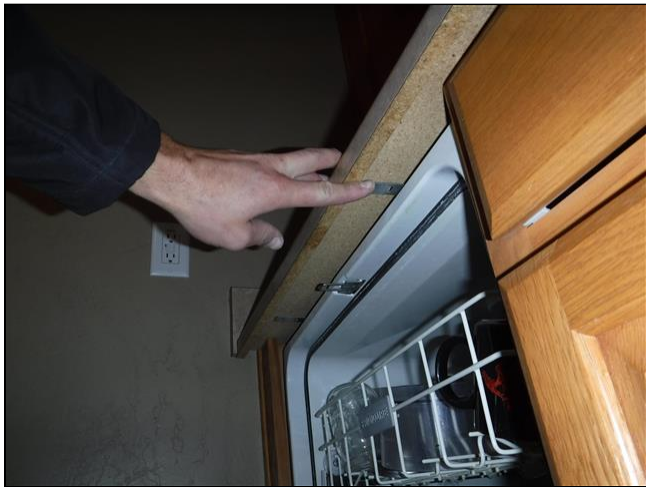
10.0 Item 1(Picture)

10.0 Dishwasher is not properly secured to counter. A qualified handyman should secure with screws.

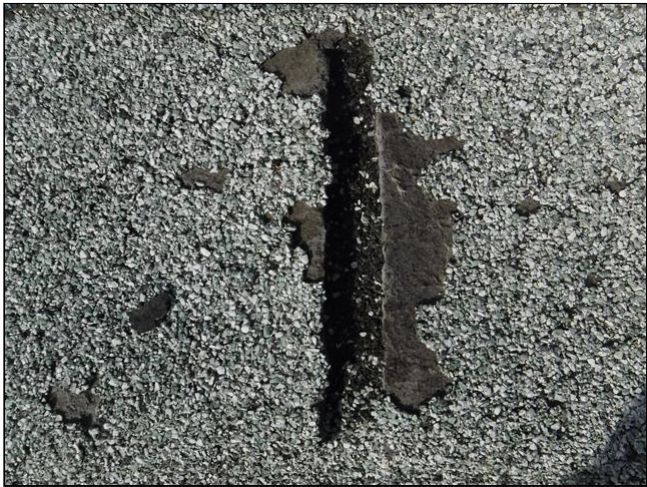
1.0 Item 1(Picture)

(1) Shingles are cupping, blistering and falling apart due to insufficient underlayment, ventilation and attic insulation I recommend getting the roof replaced by a licensed roofing contractor as soon as possible to avoid water penetration into home.

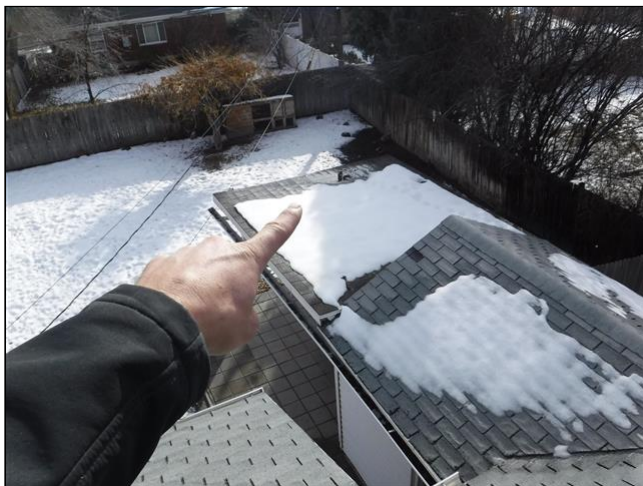
1.0 Item 7(Picture)

(2) 3 tab shingles are not designed to be used on flat roof surfaces. A licensed roofing contractor should replace with proper roofing materials to avoid water damage.

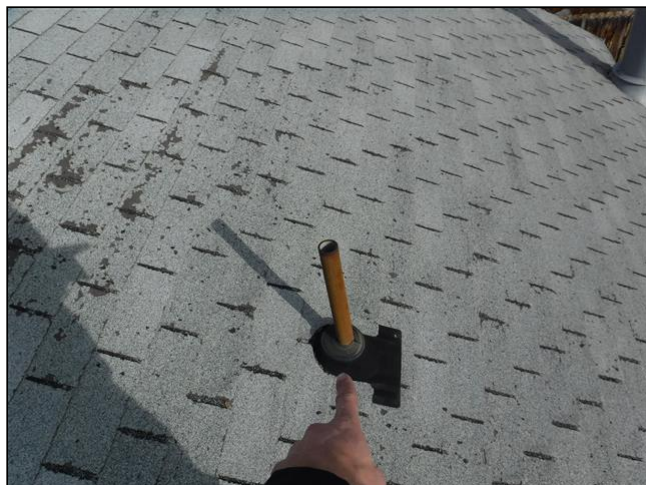
1.1 Item 1(Picture)

The vent flashings are cracked and failing. These should be replaced as soon as possible to prevent water penetration into home. A licensed roofing contractor should perform the repairs.

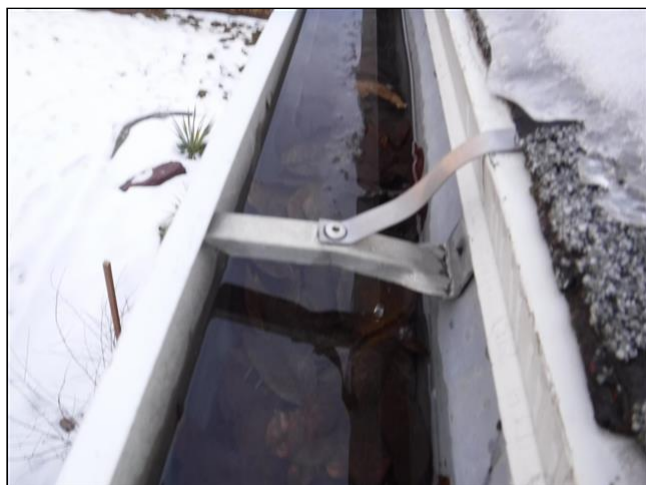
1.3 Item 1(Picture)

(1) Gutters on home need to be cleaned out in order to drain properly.

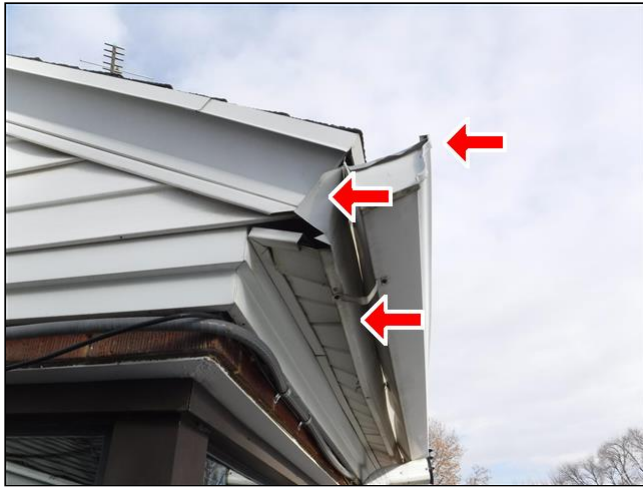
1.3 Item 3(Picture)

(2) Gutter on back side of home is pulling away from home because of improper installation. A licensed gutter contractor should repair or replace as needed.

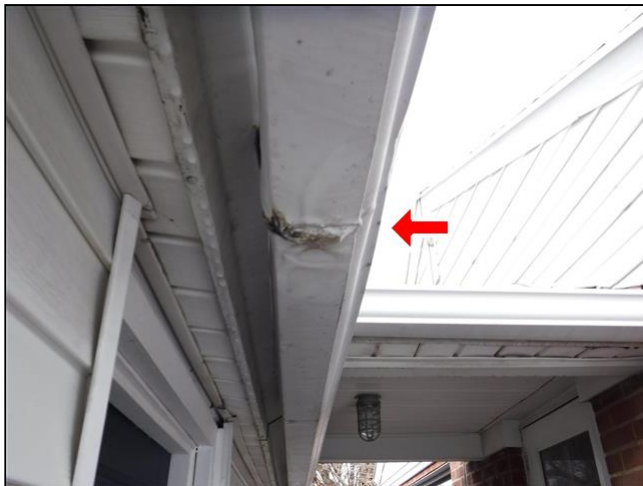
1.3 Item 5(Picture)

(3) Gutter between home and garage is broken and leaking. A licensed gutter contractor should repair or replace as needed.

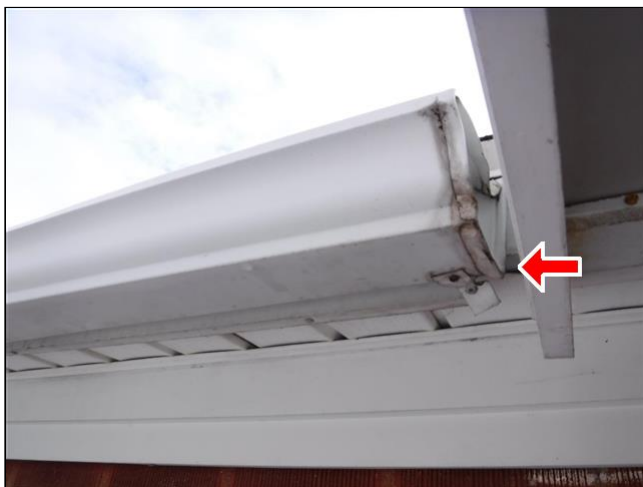
1.3 Item 7(Picture)

(4) End cap on front gutter of home is leaking. A qualified handyman should clean and re-seal as needed.

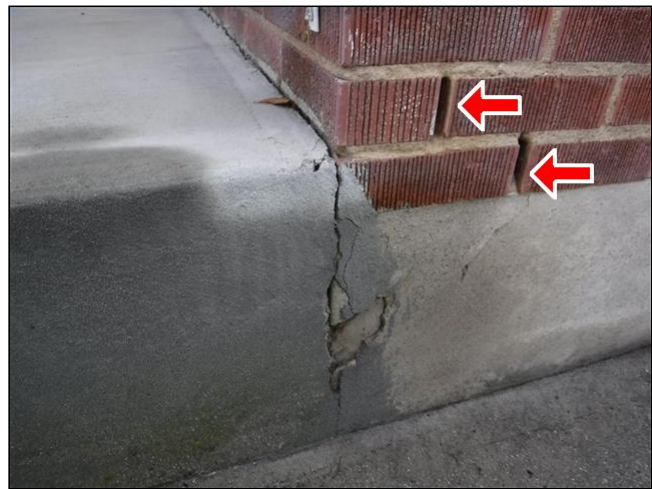
2.0 Item 1(Picture)

(1) Brick is missing mortar in various locations around exterior of home. A licensed brick mason should repair as needed.

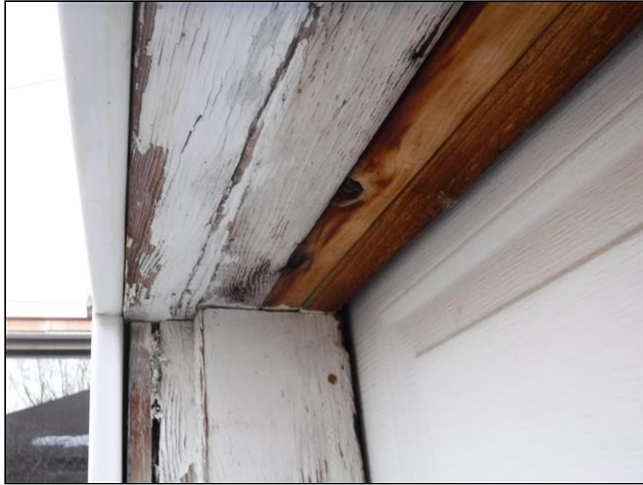
2.0 Item 5(Picture)

(2) Wood on garage needs scrapping and new paint. A qualified handyman should perform repairs.

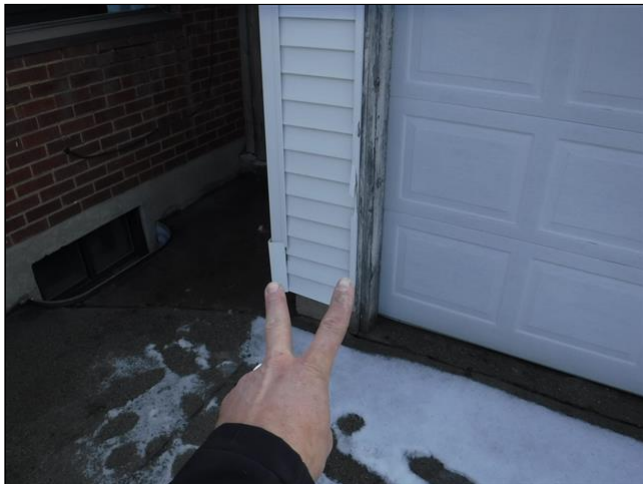
2.0 Item 8(Picture)

(3) Garage has damage to siding/trim. A licensed siding contractor should repair or replace as needed.

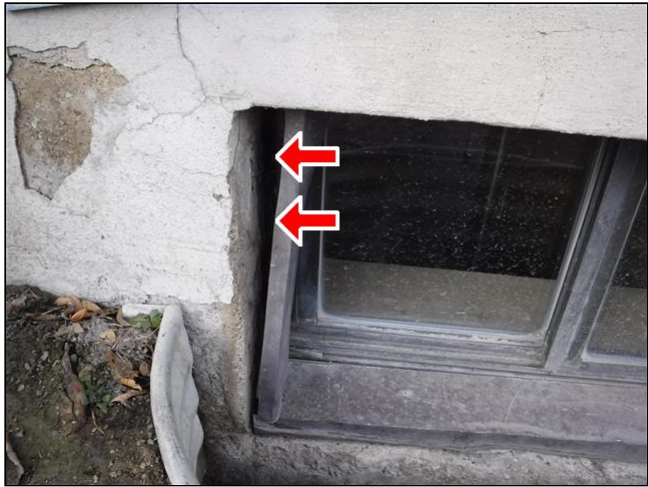
2.2 Item 1(Picture)

Laundry window has casing that is pulling away. A qualified handyman should reattach and re-seal

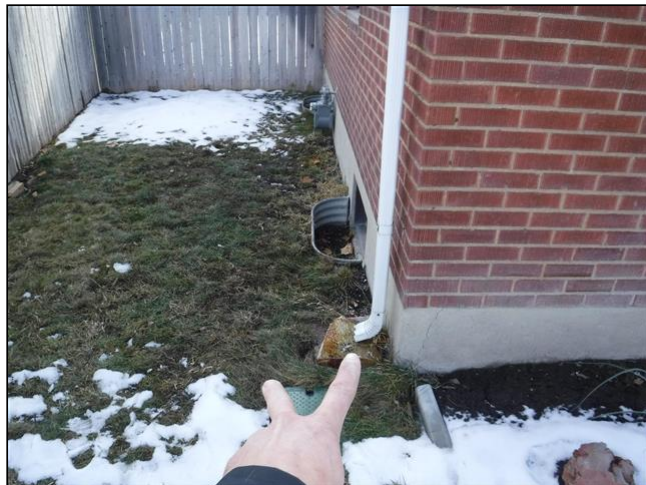
2.4 Item 3(Picture)

(2) Downspouts should be extended to direct water away from foundation of home. A qualified handyman should perform repairs.

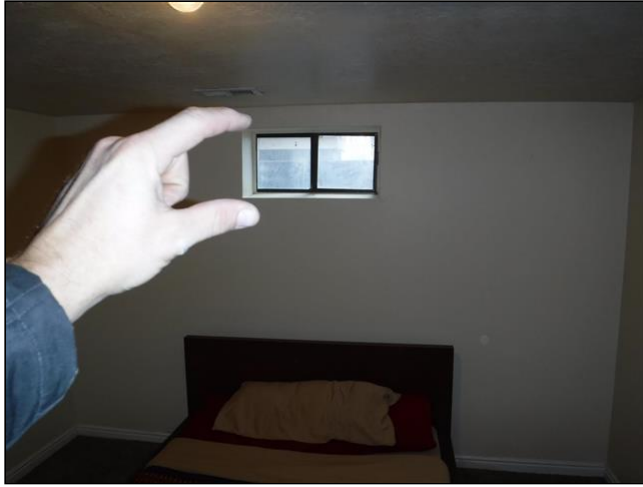
4.6 Item 1(Picture)

(1) Basement bedroom window does not meet egress standards. This room should not be used as a bedroom without proper fire escape through window opening.

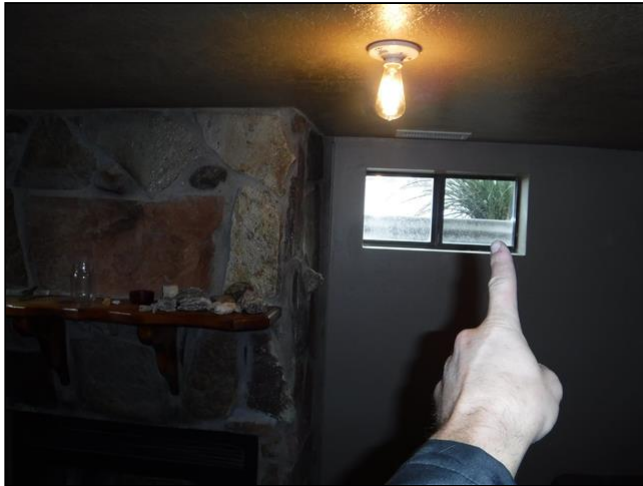
4.6 Item 2(Picture)

(2) Window pane is cracked next to basement fireplace. A licensed window contractor should replace broken window pane.

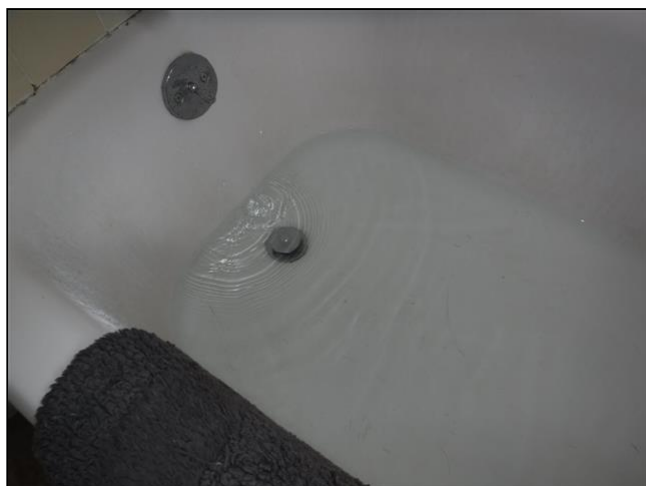
6.0 Item 3(Picture)

(2) Upstairs sink and bath tub have slow drains. A plumber should further evaluate and clear drains or fix vents as needed.

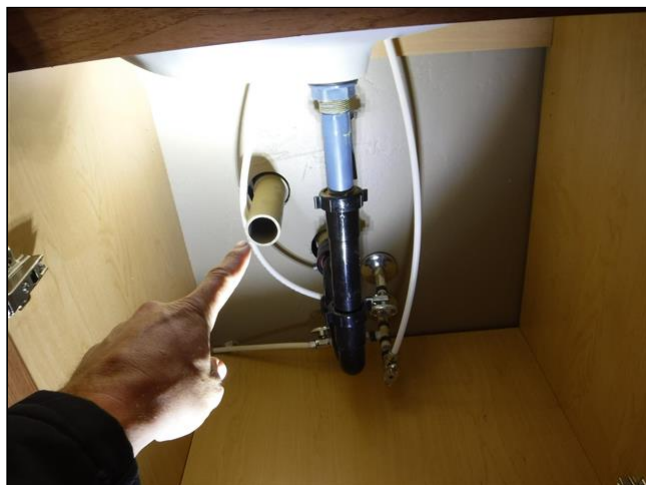
6.0 Item 5(Picture)

(3) Vent caps need to be installed in kitchen and basement bathroom. Work should be done by a qualified handyman.

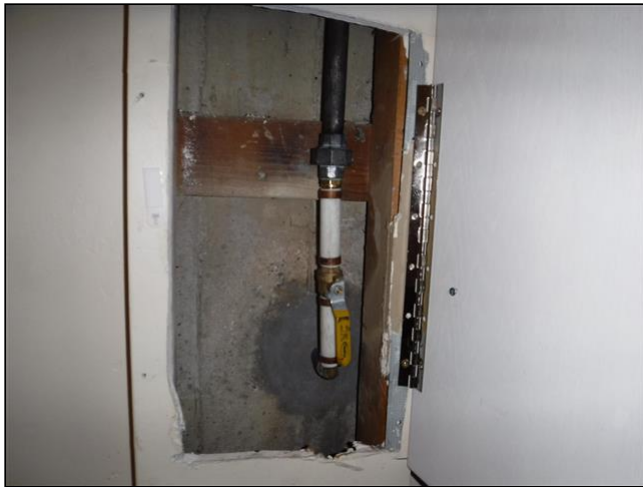
6.3 Item 1(Picture)

(1) Main water shut off is in basement bedroom.

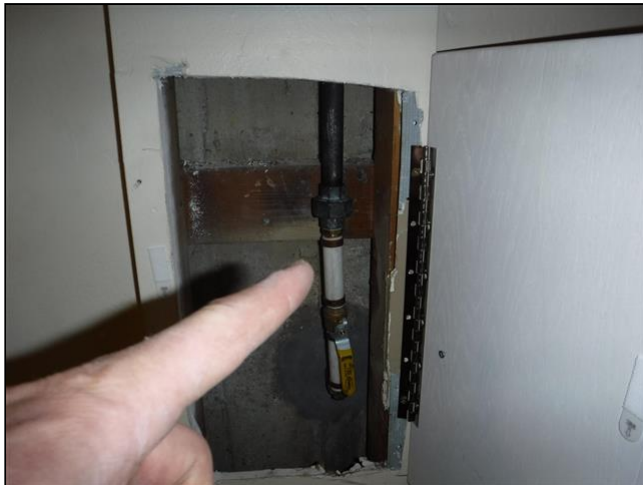
6.3 Item 2(Picture)

(2) The pressure in the water system is over 100 psi. A proper water pressure for a residential home is around 50 psi. A pressure regulator valve should be installed in front of main water shut off to bring water pressure to the proper level.

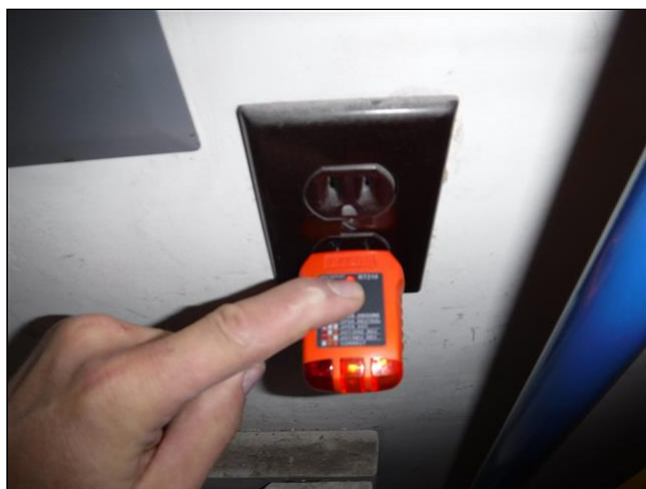
7.5 Item 1(Picture)

(1) Garage outlets are not protected by GFCI outlets. A licensed electrician should install GFCI protection as needed.

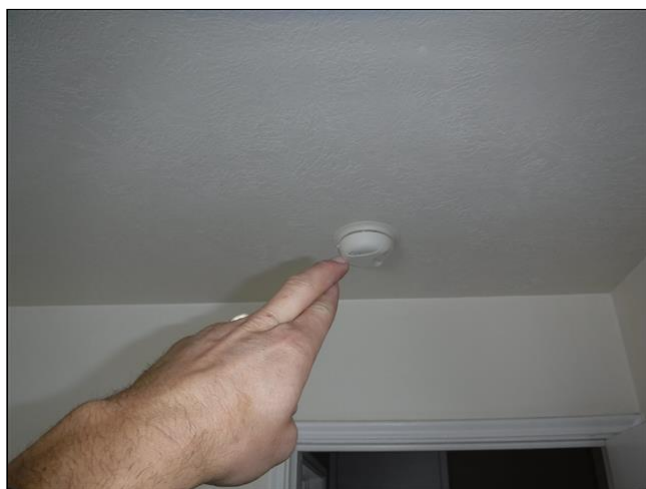
7.7 Item 1(Picture)

The smoke detector should be tested at common hallway to bedrooms upon moving in to home. Smoke detector in upstairs bedroom is not functioning properly. The battery or the whole smoke detector should be replaced as needed.

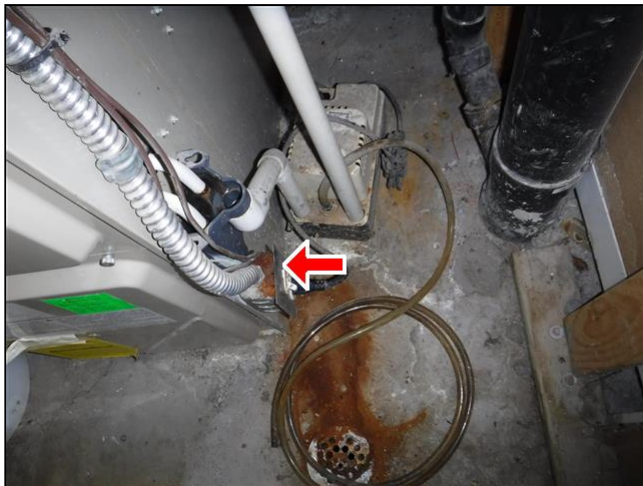
8.0 Item 2(Picture)

(2) There is water damage to the power control for the heater. A licensed HVAC professional should repair or replace damaged parts as necessary.

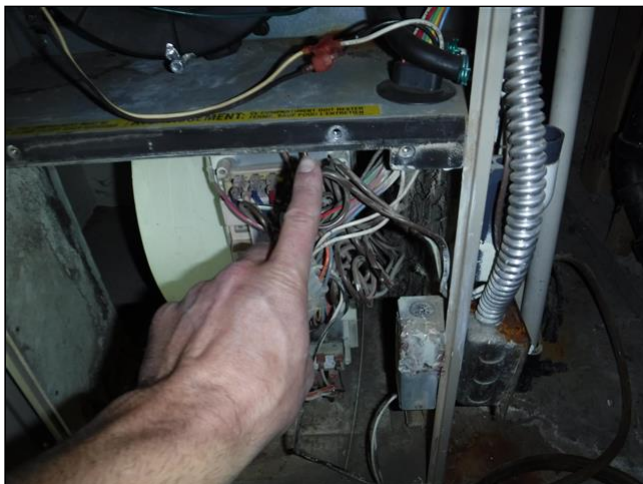
8.2 Item 1(Picture)

Automatic safety control is missing. A licensed HVAC specialist should install proper safety control.

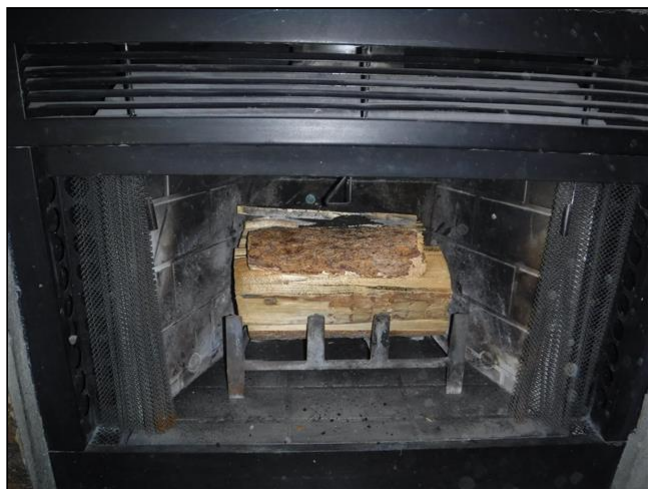
8.6 Item 1(Picture)

You should not burn wood in a gas fireplace. This can be a fire hazard and could fill your home with smoke.

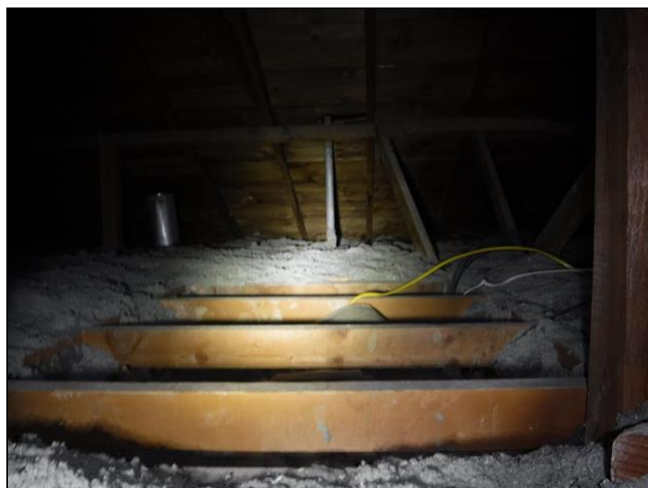
9.0 Item 1(Picture)

There is insufficient insulation in attic and no insulation on access panel. Proper insulation should be installed to prevent heat loss and high heating costs.

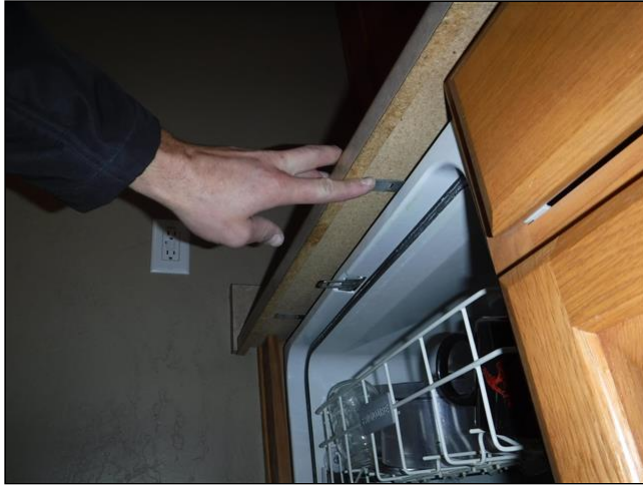
10.0 Item 1(Picture)

Dishwasher is not properly secured to counter. A qualified handyman should secure with screws.
